Nutrient Dynamics in the Spoon River Watershed

Jose Zavala and Lowell Gentry*
The Department of Natural Resources and Environmental Sciences at the University of Illinois at Urbana-Champaign*

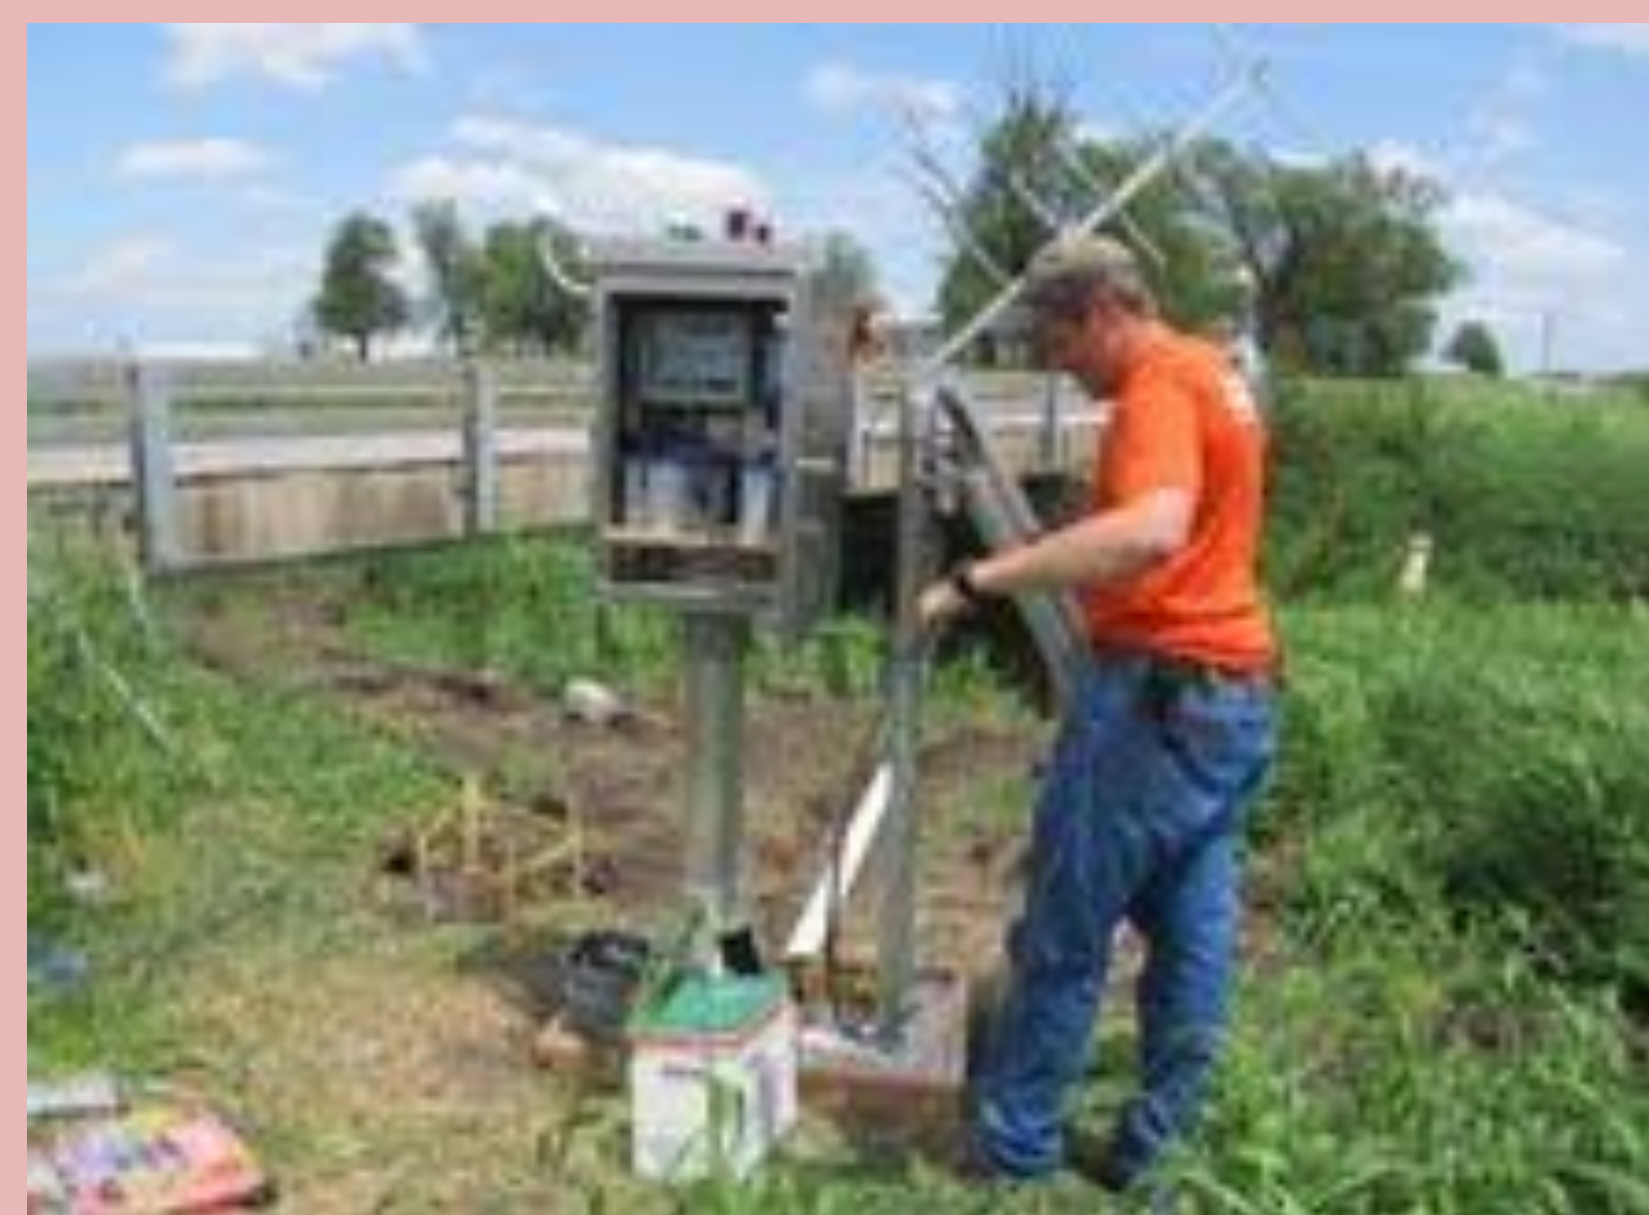
USGS field technician, Clayton Bosh, is installing a stage height recorder and nitrate sensor in the Spoon River. Stage height is measured with a radar sensor mounted beneath the bridge and a rating curve is being developed. The HACH nitrate sensor continuously measures real-time nitrate concentrations.

- Our secondary objective is test and assess the newly installed real-time nitrate sensor in the Spoon River watershed outlet.

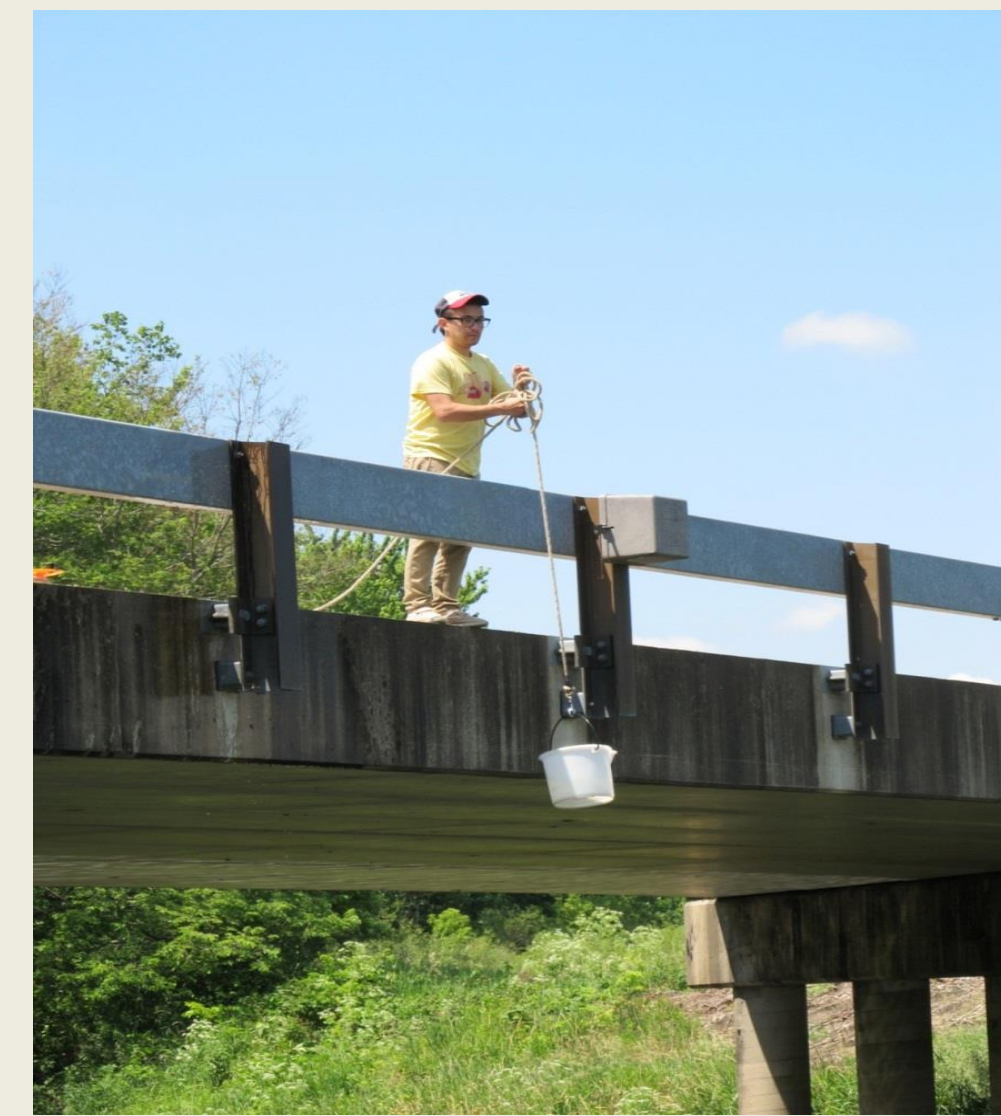
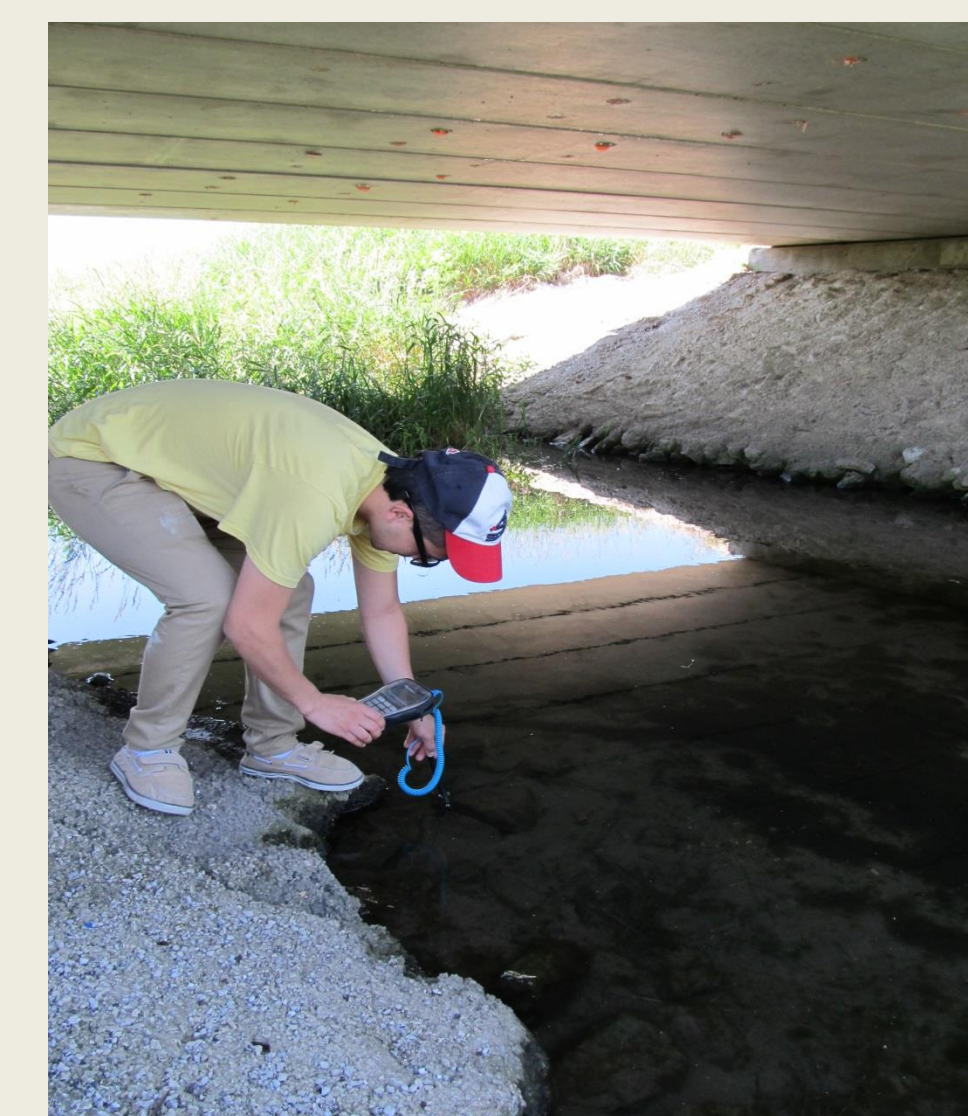
This shows the procedure taken in order to collect the river sample from each bridge.

Along the Spoon River Watershed, we collected 10 samples, lowering a bucket from each bridge. Samples were collected on road 2900 N (site 1), above and below Gifford sewage effluent (sites 2 and 3), on 2700 N (site 4), 2300 E (located on the East Branch of the Spoon River (site 5), on 2600 N (site 6), on 2500 N (site 7), on 2400 N (site 8), and 2100 N (site 9), following to the Spoon River outlet on road 1950 N (site 10) above the confluence of the Spoon River and the Salt Fork Ditch, and finally an eleventh sample was collected at the USGS gauge on road 1850 N (site 11). See map below.

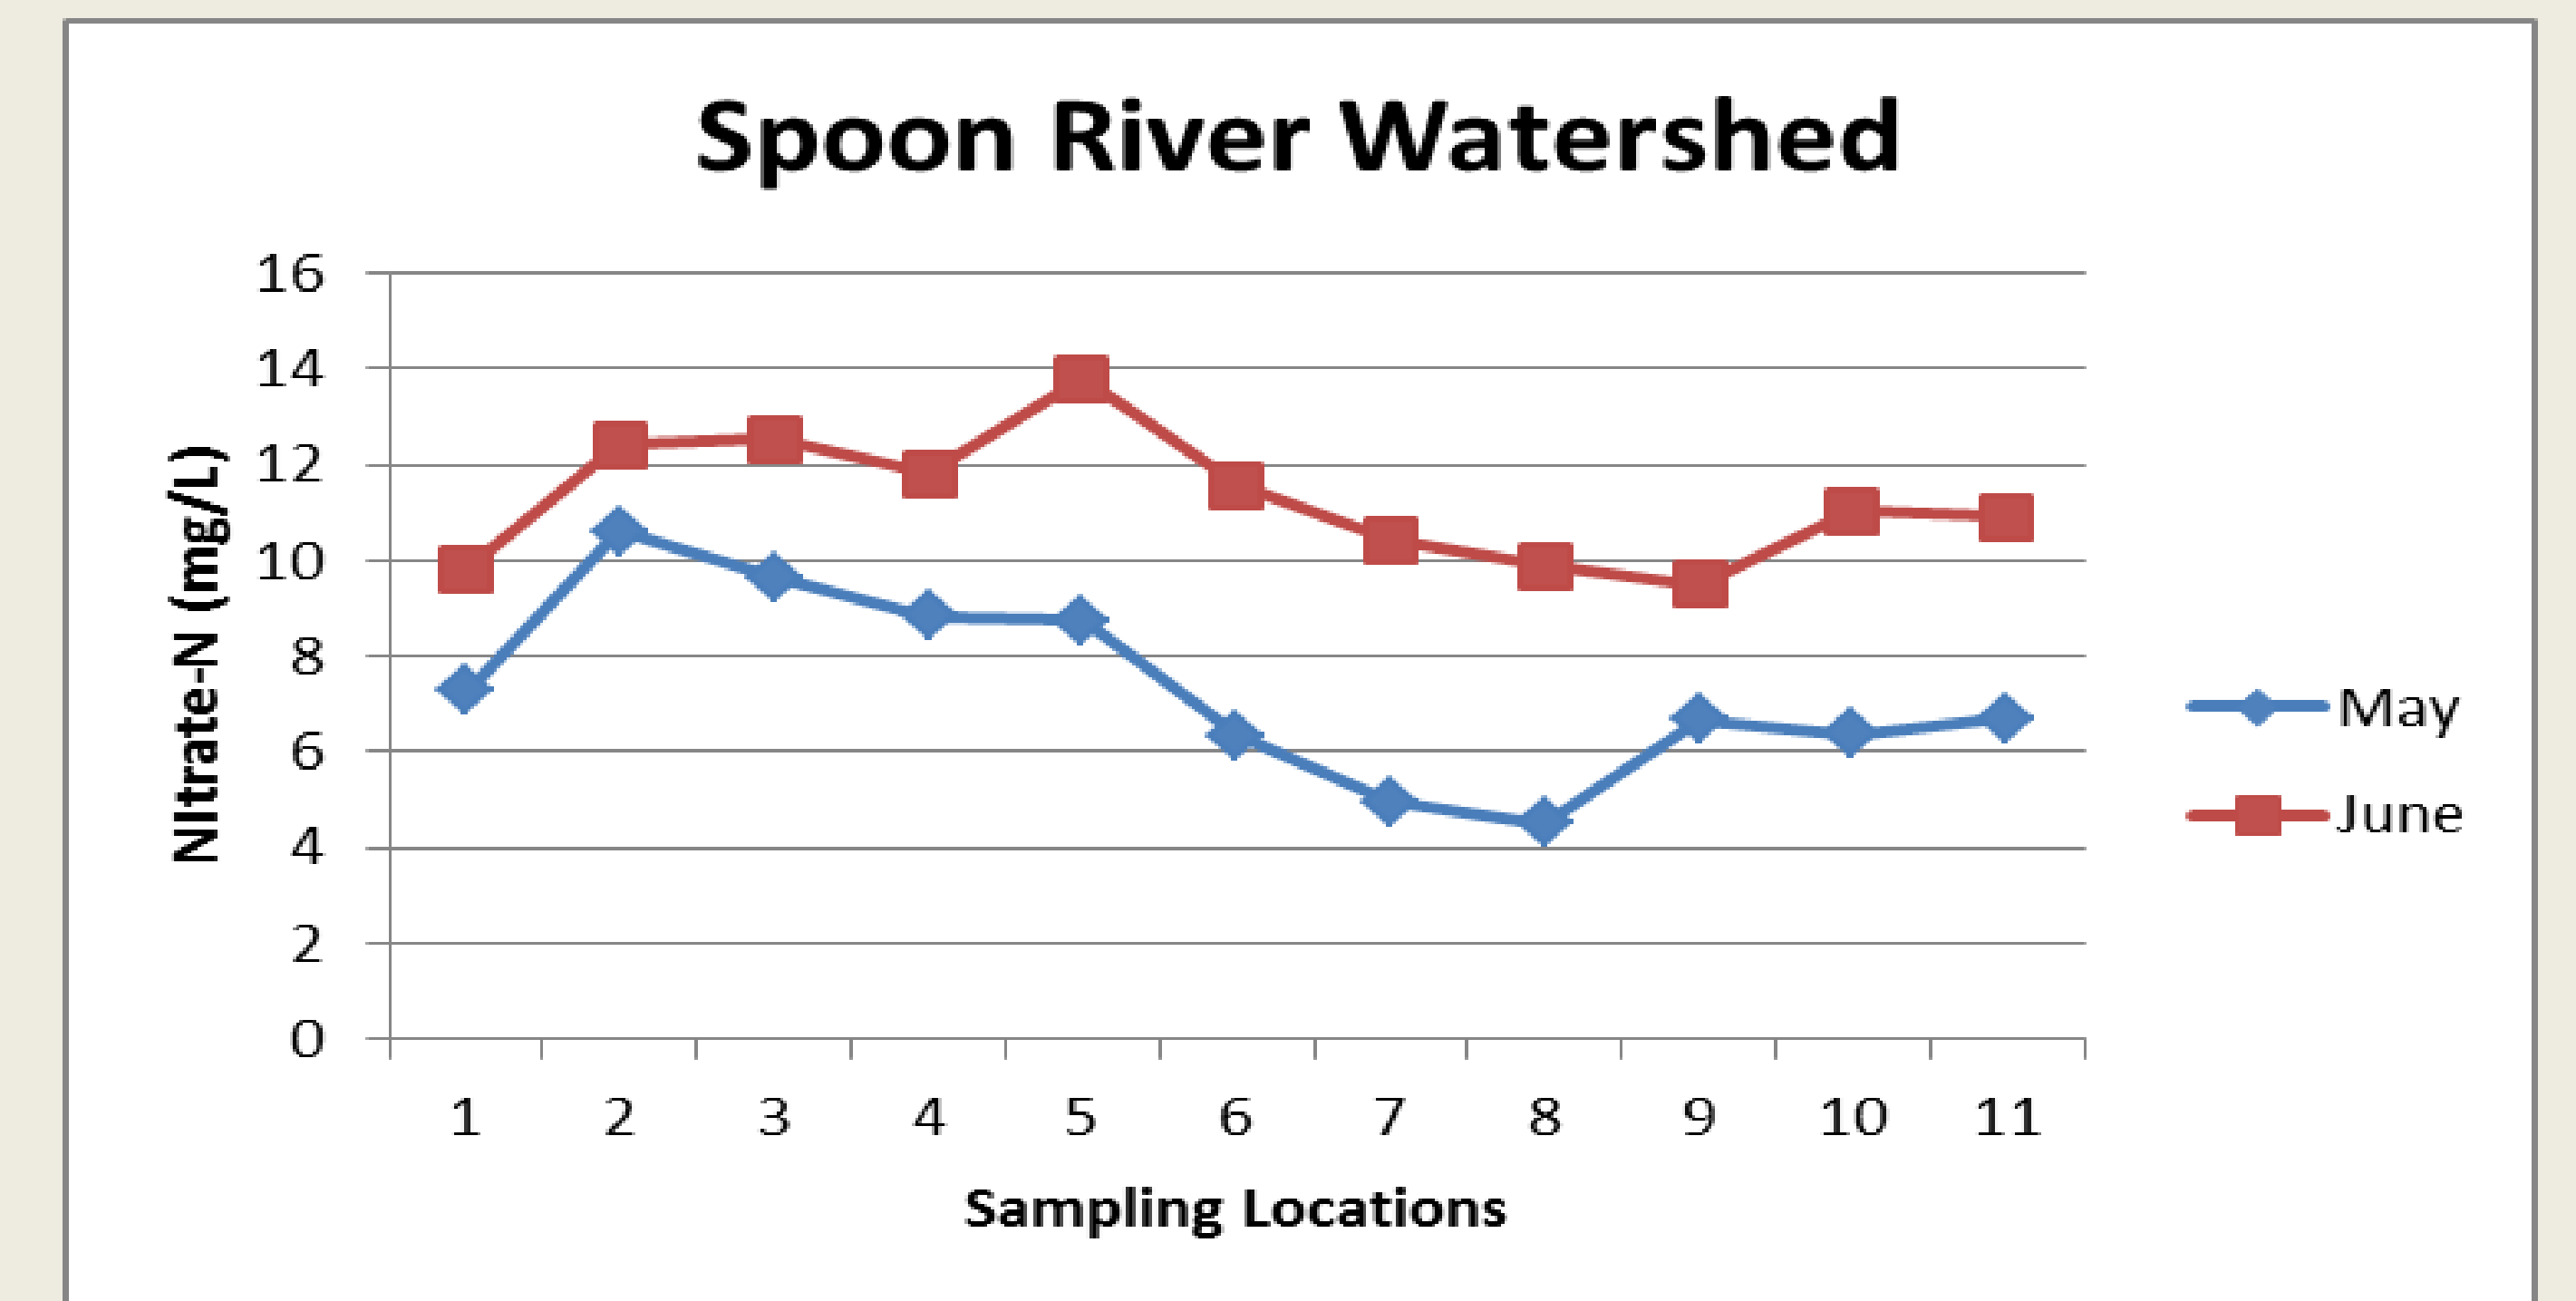
Figure 1. Nitrate concentrations when tiles were flowing at 10 sites collected on the Spoon River watershed in May 23, 2013 and June 4, 2013. Note: site 11 is the outlet for the entire Upper Salt Fork watershed.

The figure illustrates that as the river flows downstream the nitrate concentration generally decreased.

On May 23 the nitrate concentration ranged from 4 to 11 mg/L across all eleven bridge sites with an average of 7.3 mg/L. On June 4 the nitrate ranged from 9 to 14 mg/L across all eleven bridge sites with an average of 11.3 mg/L (Figure 1).
